## Stormwater Utility Division – Grape Street Detention Pond

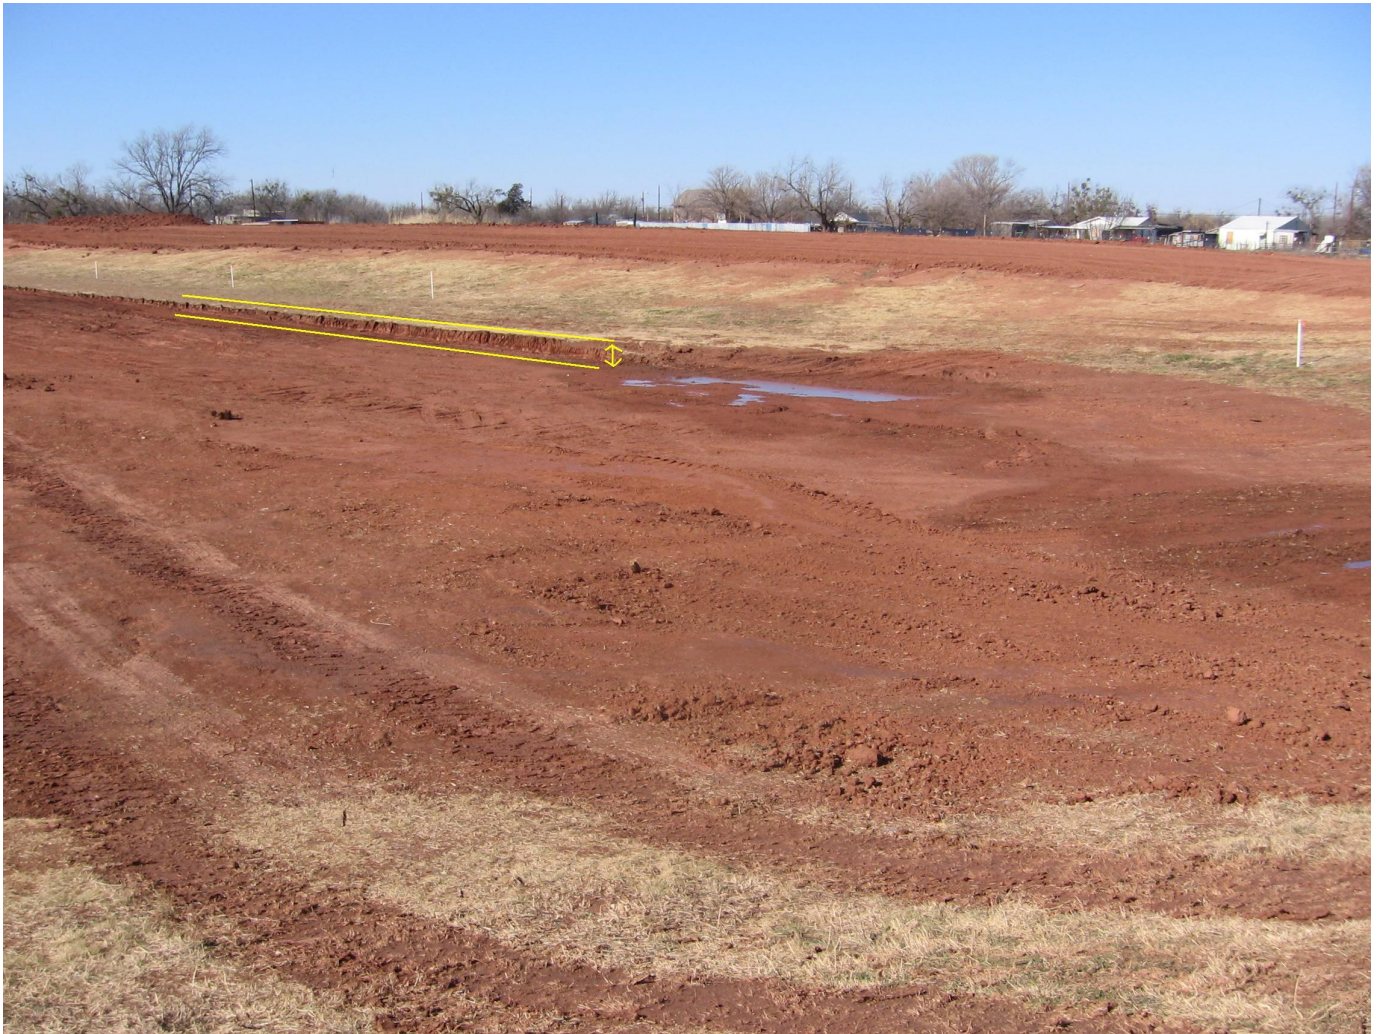
Initial cuts on detention pond (notice 18' of silt layer at top of picture).

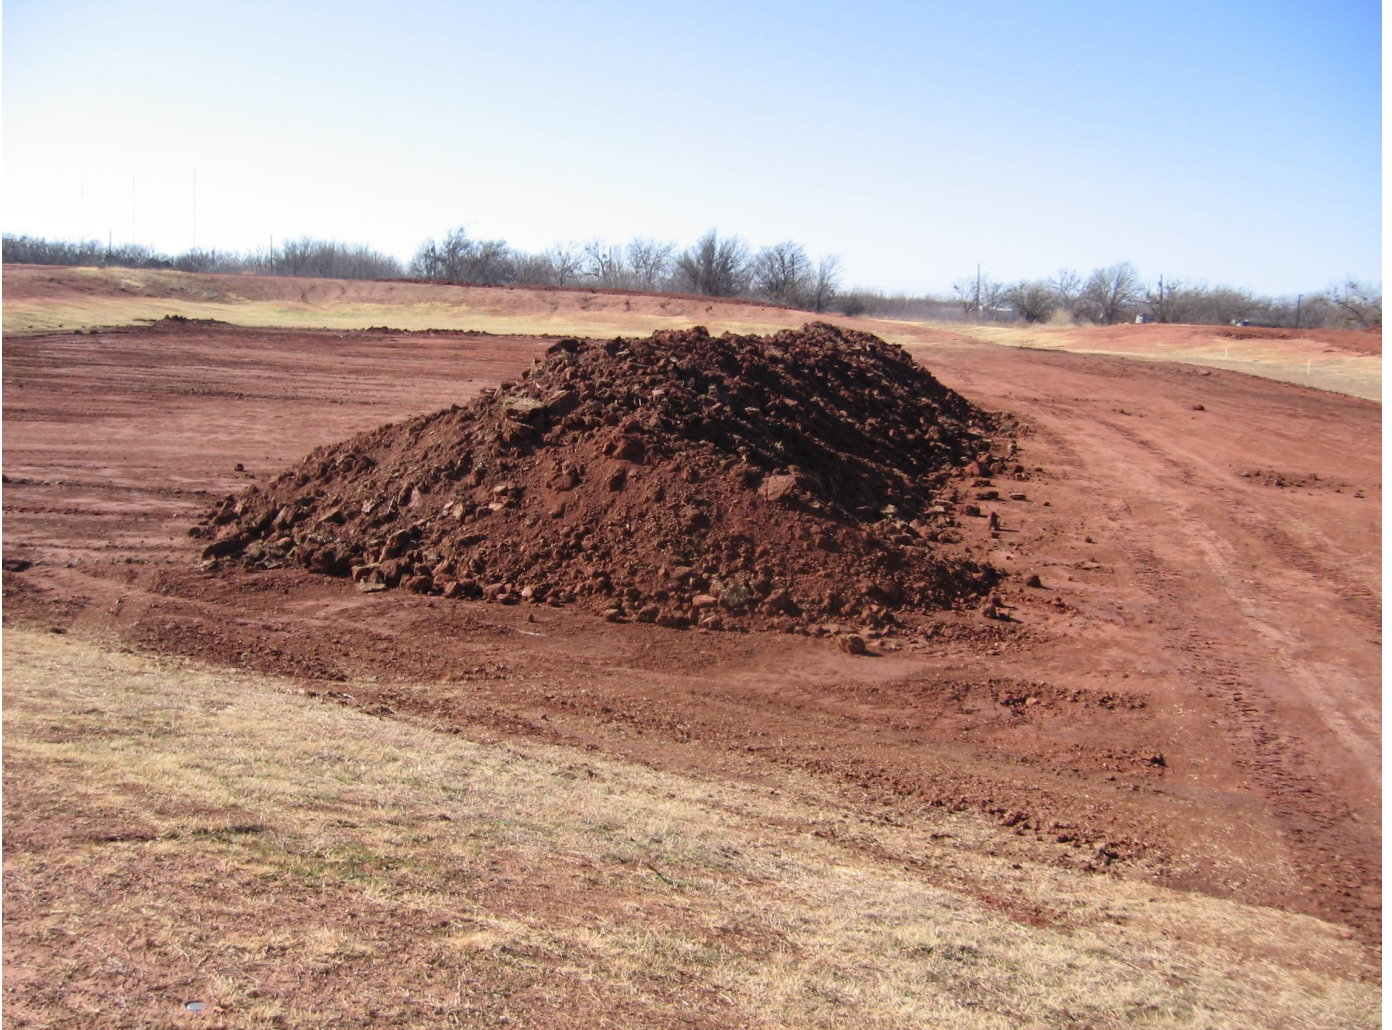
Initial stockpile of sediment to be removed. Several additional cuts were performed later to get the detention pond back to original specifications.

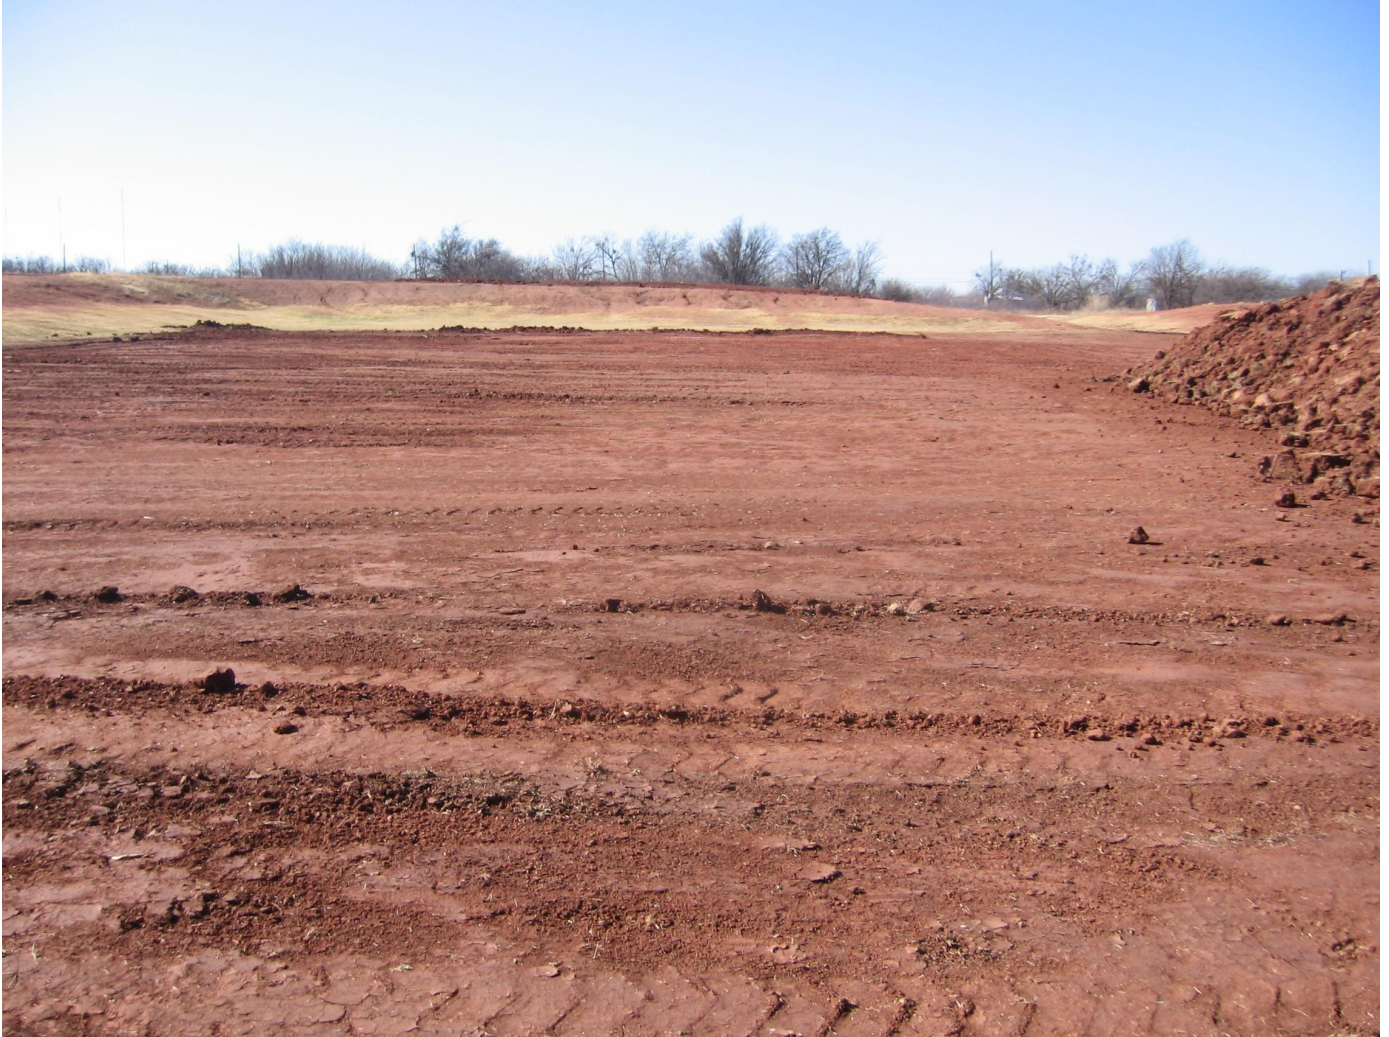
Graded detention pond ready for additional cuts.
